**GEOTECHNICAL INVESTIGATION
BANNING AIRPORT INDUSTRIAL PARK
BANNING, CALIFORNIA**

GEOTECHNICS INCORPORATED
Project No. 1060-001-00
Document No. 05-0621

July 7, 2005

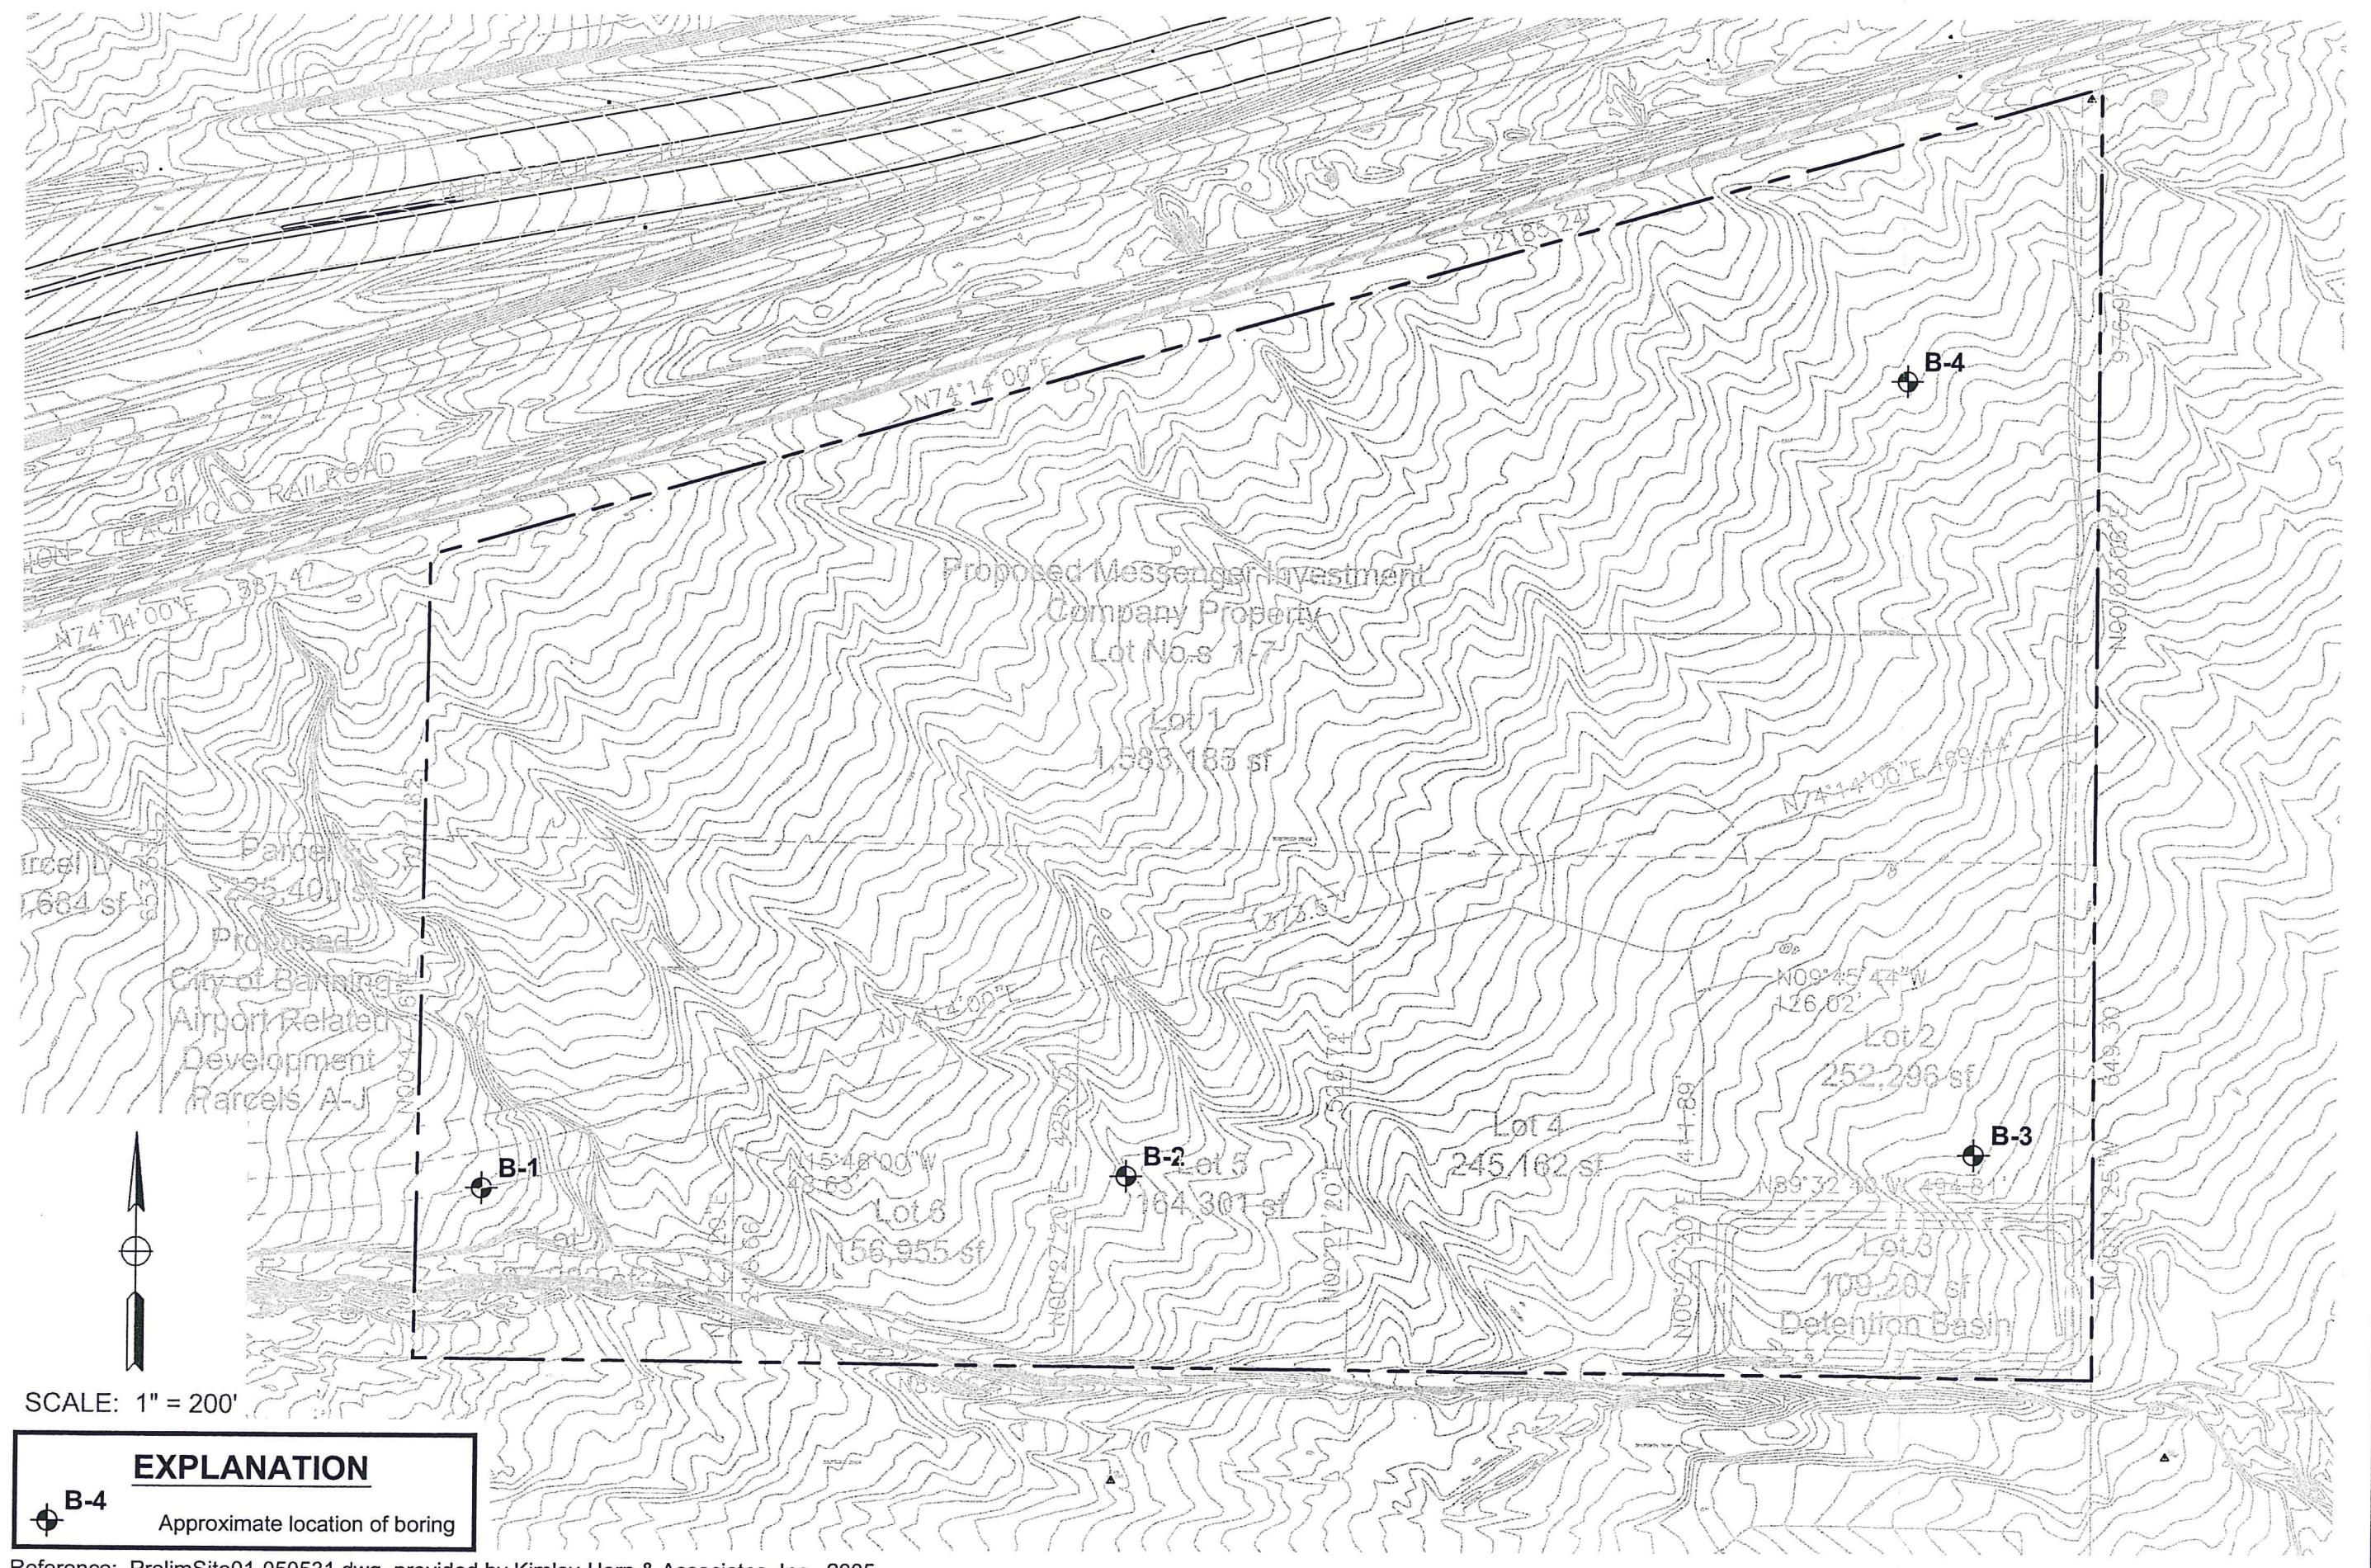
EXPLORATION PLAN

Alluvium was encountered in all of our borings across the site to the maximum depth explored. As observed in our borings, the alluvium is generally composed of poorly graded sand with silt and gravel (Unified Soil Classification SP-SM) and poorly graded gravel with silt and sand (GP-GM) with varying amounts of gravel and cobble size clasts of granitic and gneissic composition. The alluvium is generally light brown, brown, and light gray in color, fine to coarse grained, and dry to moist.

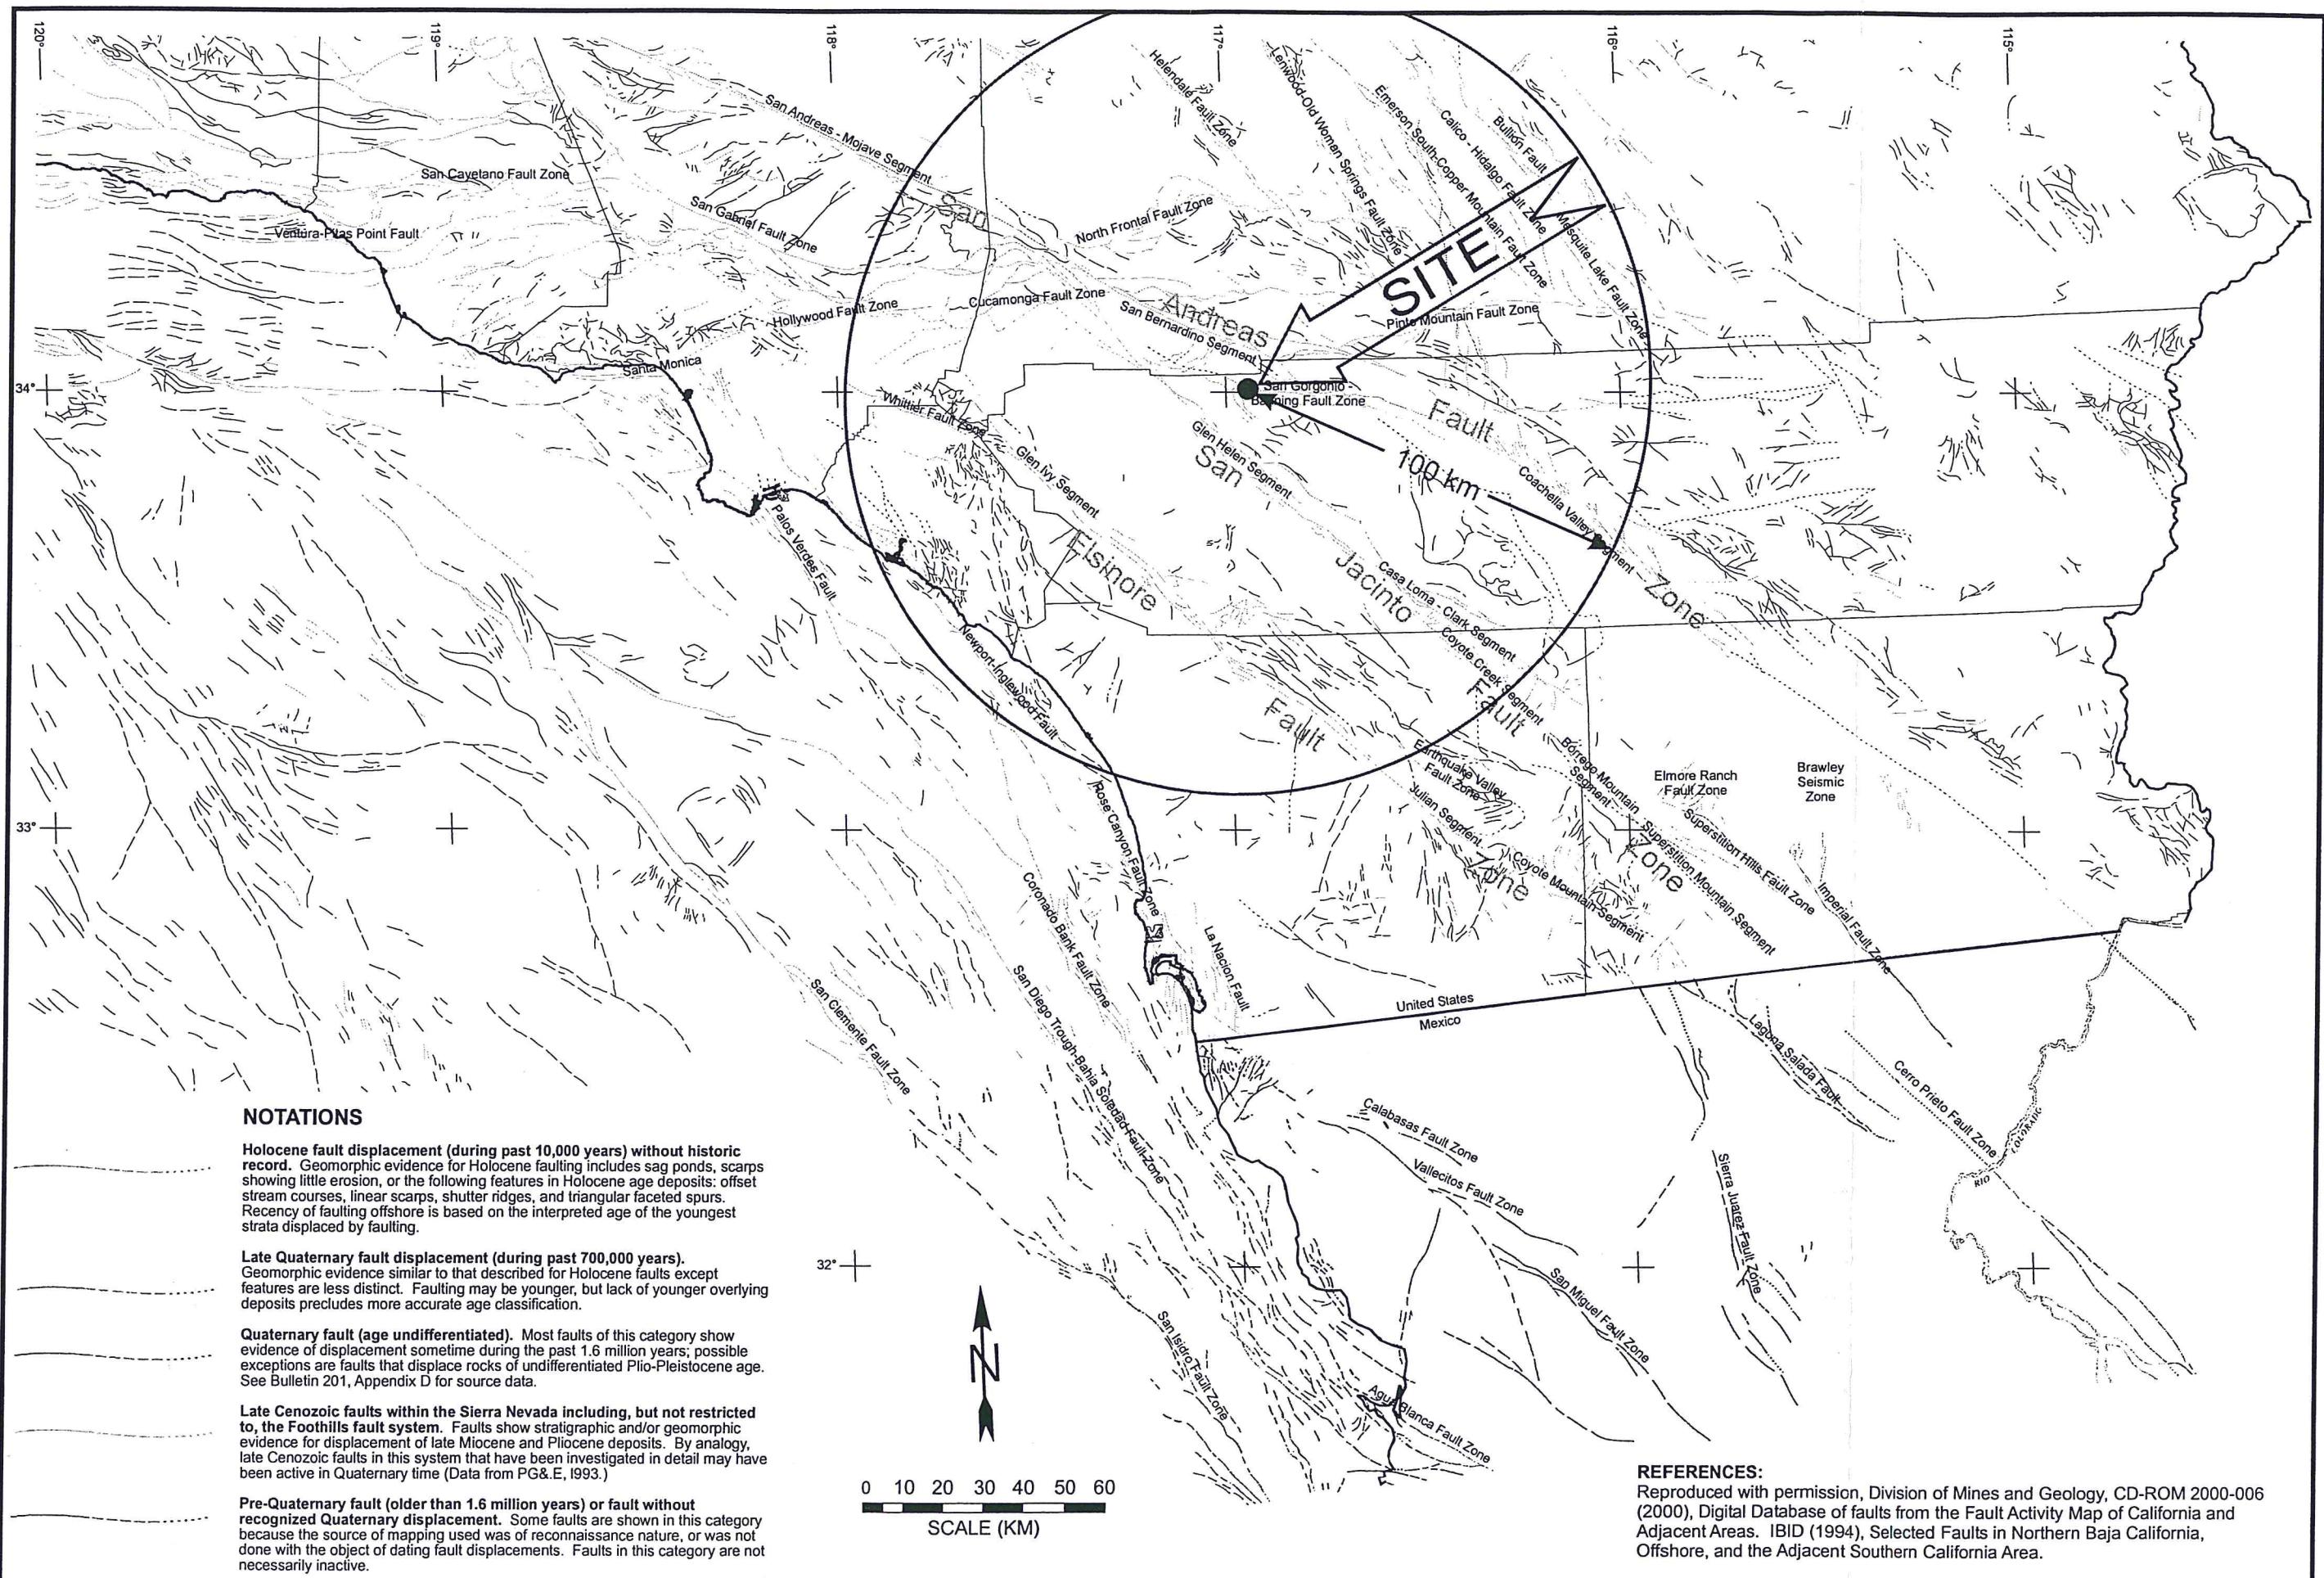
FAULT LOCATION MAP

Surface rupture is the result of movement on an active fault reaching the surface. The Fault Location Map, Figure 3, shows the relationship between known active faults in the region and the site. The nearest known active fault is the San Gorgonio Pass fault zone associated with the southern San Andreas fault zone which is located about 1.3 miles (2.1 kilometers) northeast of the site based on the State of California Earthquake Fault Zone Map of the Cabazon Quadrangle (CDMG, 1995).

There are no known active faults underlying the site, and the site is not located within an Alquist-Priolo Earthquake Fault Zone. Accordingly, it is our opinion that there is a low probability of surface rupture due to faulting beneath the site. Additionally, lurching and ground cracking are a possibility as a result of a significant seismic event on a nearby active fault.

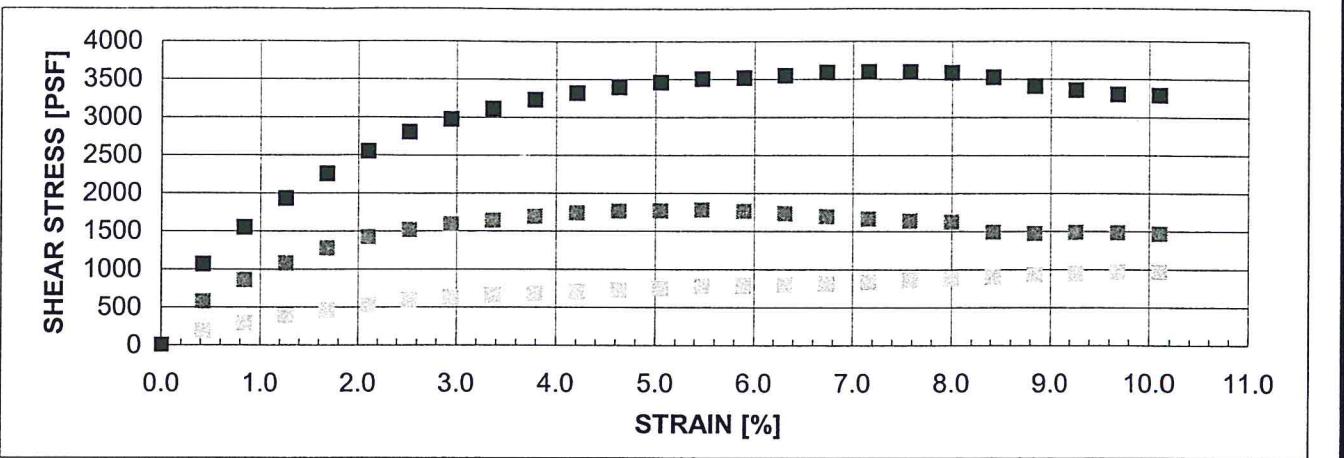
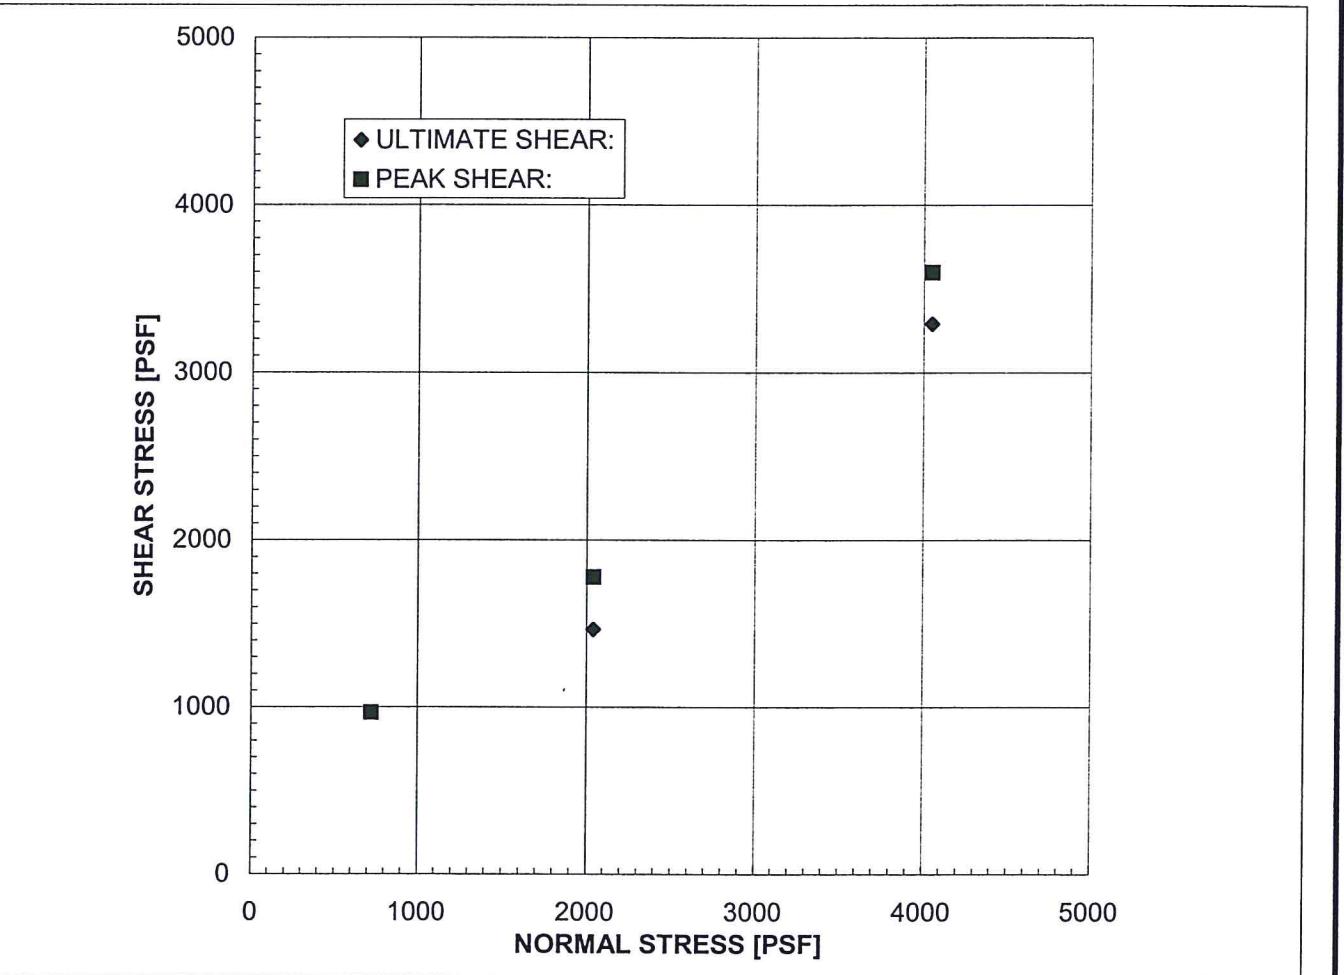
FIGURE C-5

R-Value: R-value tests were performed on a selected soil sample in general accordance with the laboratory procedures outlined in ASTM D 2844. The test results are given in Figure C-5.

Direct Shear: The shear strength of a selected soil sample was assessed through direct shear testing performed in general accordance with the laboratory procedures outlined in ASTM test method D 3080. The sample was re-molded to 90 percent of the maximum dry density. The results are summarized in Figure C-5.

SAMPLE: B-3 at 5' to 10'

Gray to brown poorly graded sand with silt and gravel (SP-SM) {Re-molded to 90%}
